Stanley W. Trimble
Geog. Dept., U. of Ga.Field Investigation Reports to Accompany
the M. A. Thesis, Culturally Accelerated
Sedimentation on the Middle Georgia Piedmont (U. of Ga, 1969)

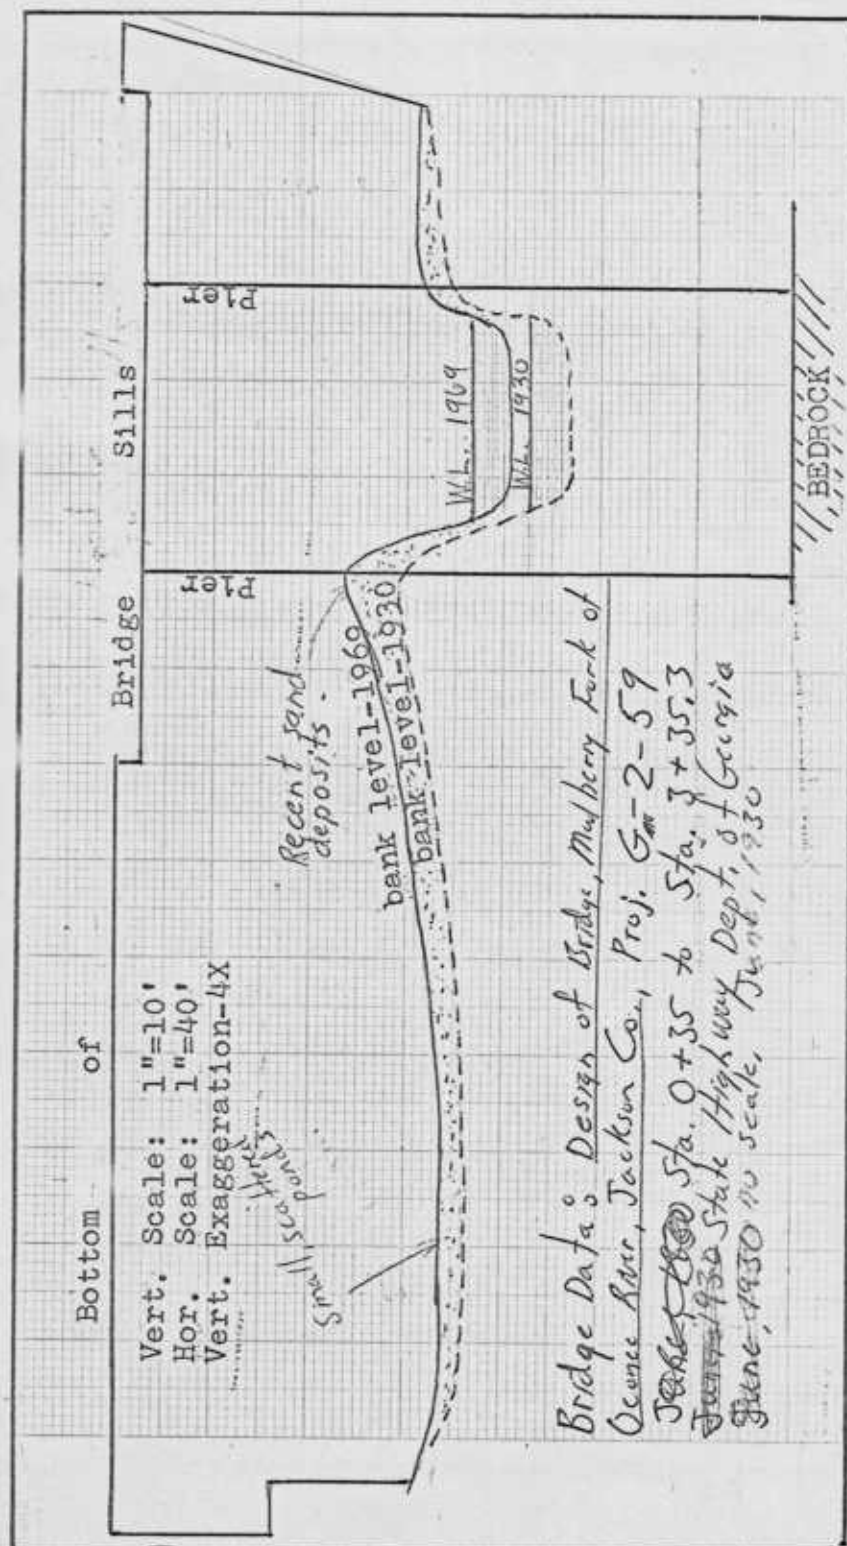
Mulberry River at the U.S. Highway 11 Bridge
Transverse Stream Profile

There has been only three feet of aggradation at this point since 1930, as shown in Fig. 9. Judging from the recent deposits of sand along the natural levees, much of the channel aggradation may also be recent. The present owner of the site stated, however, that there has been no noticeable aggradation in the past fourteen years that he has owned the land.¹ It is the investigator's opinion that the large accumulation of sediment, now situated upstream from the Highway 53 bridge to below the old Moon Bridge, will continue to move downstream. The valley floor on the right bank at this site is now a rich pasture. As shown in the ^{Fig 9} ~~Diagram~~, if the river channel aggrades only two more feet, much of the adjoining valley floor will be inundated. Should this happen, the land will probably be abandoned to become swamp as has happened upstream.
